RJN Oversees Bridge Deck Patching Over the Edens

Full depth patching was required to repair the Edens Spur Bridge deck

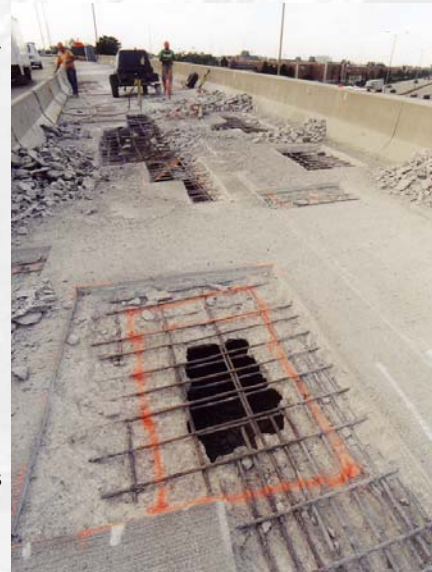
During the winter, Tollway maintenance personnel were continually placing asphalt cold patches in a growing series of potholes in the concrete bridge deck. The potholes intensified with each freeze-thaw cycle. In the Spring, one of the potholes poked through the entire deck, showering debris over the Northbound lanes of the Edens Expressway. The majority of the deterioration on the two-lane bridge was concentrated on the outside truck lane. This lane was immediately barricaded off and closed to traffic.

Within one month the Toll Authority developed plans and started repairs. RJN personnel sounded the entire bridge deck for deteriorated concrete with metal bars and hammers. In order for a complete analysis of the deck condition to be performed, the contract provisions required the contractor to provide the engineers access to the underside of the deck. With the use of a scissor-jack lift and nighttime lane closures on the expressway, the underside was sounded. Cherry pickers were used to access the undersides above the slopewalls.

Based on comparison of the soundings from above and below, RJN mapped out areas of partial and full depth bridge deck repairs. This work was done in two stages. The majority of the full depth repairs were performed on the outside truck lane, as expected, during Stage I. Surprisingly, the inside lane, which exhibited virtually no visible signs of distress, was found to require extensive partial depth repairs. This was attributed to delamination of the existing concrete deck overlay.

High early strength concrete with a strength of 3,000psi within 36 hours was used on the deck repairs so that the lanes were quickly reopened. Upon completion of this project, the aging Edens Spur Bridge deck was given a new lease on its life.
